EXTENDED PHASE 1 HABITAT SURVEY & DAYTIME BAT SURVEY AT PRESTON NORTH END TRAINING GROUND, LEA, PRESTON, LANCASHIRE

2019

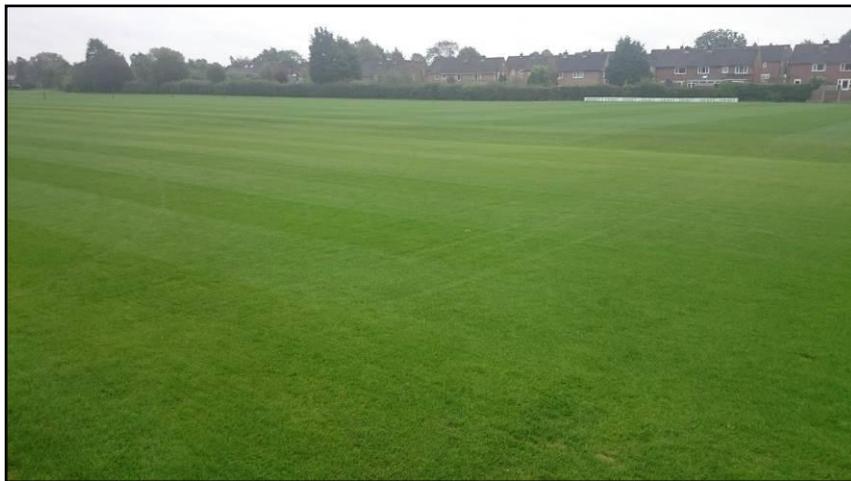
Photograph 1 showing the amenity grassland

- 3.2 The site supports intensively managed amenity grassland, which is used as football pitches. The sward height is kept to no more than 15mm across the pitches (see the front cover page and Photograph 1). The species-poor grassland is dominated by Perennial Rye-grass *Lolium perenne*. The area of amenity grassland within the western half of the site is not as intensively managed, with a slightly taller sward.

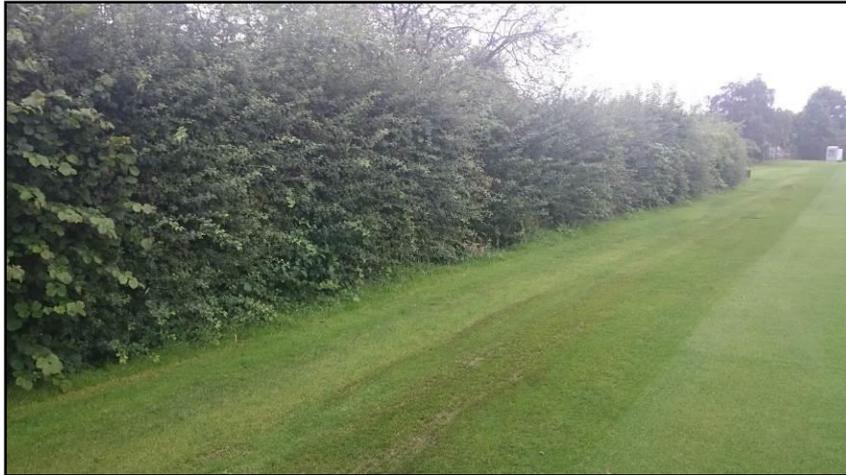
Photograph 2 showing one of the hedgerows along the southern of the site

- 3.3 Hedgerows occur intermittently along the southern boundary of the site (see Photograph 2). The hedgerows are intact and largely well-managed. The hedgerows are dominated by Hawthorn *Crataegus monogyna*, with Hazel *Corylus avellana*, Sycamore *Acer pseudoplatanus*, Field Maple *Acer campestre*, Honeysuckle *Lonicera periclymenum*, Elder *Sambucus nigra* and Rose *Rosa* sp. A large Leyland Cypress *Cupressus leylandii* windbreak/hedgerow is located towards the southern boundary of the site (see Photograph 3). This has been marked as a hedgerow on the Phase 1 Habitat Map.

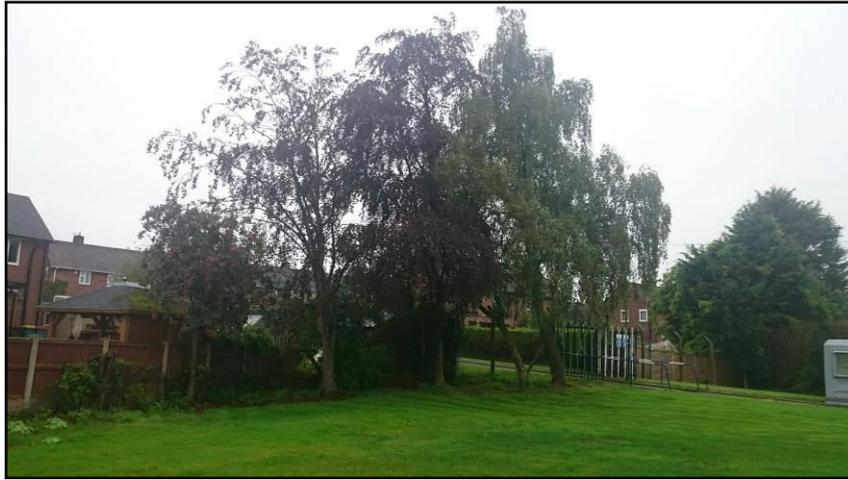
Photograph 4 showing trees on site located along the southern boundary, adjacent to the access road

- 3.4 Scattered trees are located along the southern and western boundaries of the site (see Photographs 4 and 5). Species include Hornbeam *Carpinus betulus*, Copper Beech *Fagus sylvatica f. purpurea*, Silver Birch *Betula pendula*, Wild Cherry *Prunus avium*, Sycamore *Acer pseudoplatanus*, Poplar *Populus sp.*, White Willow *Salix alba* and Alder *Alnus glutinosa*.

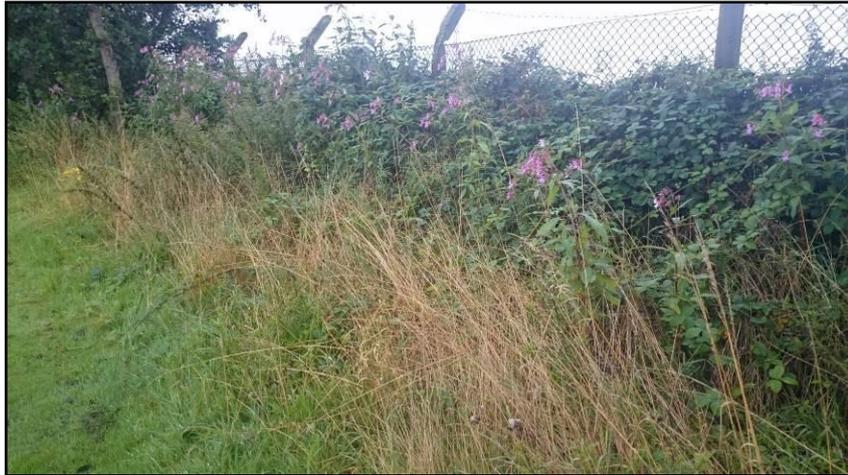
Photograph 6 showing an area of tall, ruderal herb

- 3.5 Tall, ruderal vegetation is present around the peripheries of the amenity grassland in the western half of the site, and around areas of continuous scrub and scattered trees (see Photograph 6). A large, established area is present in the north-western corner (see Photograph 7). Abundant species include Broad Leaved-dock *Rumex obtusifolius*, Cleavers *Galium aparine*, Common Nettle *Urtica dioica*, Rosebay Willowherb *Chamaenerion angustifolium*, Himalayan Balsam *Impatiens glandulifera*, Cow Parsley *Anthriscus Sylvestris*, Hogweed *Heracleum sphondylium*, Cock's-foot *Dactylis glomerata*, Hedge Bindweed *Calystegia sepium*, Common Ragwort *Jacobaea vulgaris*, Reed Canary-grass *Phalaris arundinacea*, Creeping Thistle *Cirsium arvense*, Dandelion *Taraxacum officinale* agg., Horsetail *Equisetum* sp. and Common Vetch *Vicia sativa*.

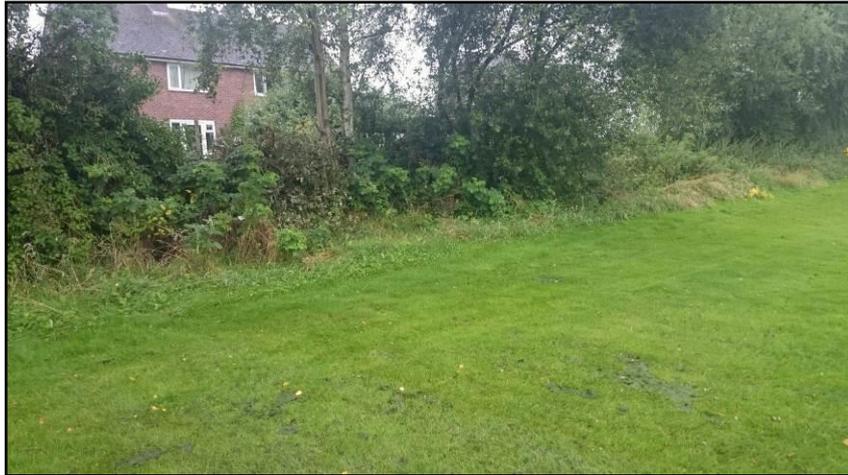
Photograph 8 showing a section of continuous scrub along the southern boundary

- 3.6 Continuous scrub is located along the western part of the southern boundary (see Photograph 8). The origins of this habitat are likely to be an unmanaged hedgerow. Species present include Garden Privet *Ligustrum ovalifolium*, Hawthorn *Crataegus monogyna*, Silver Birch *Betula pendula*, Common Ragwort *Jacobaea vulgaris*, Creeping Thistle *Cirsium arvense*, Common Nettle *Urtica dioica* and Broad-leaved Dock *Rumex obtusifolius*.

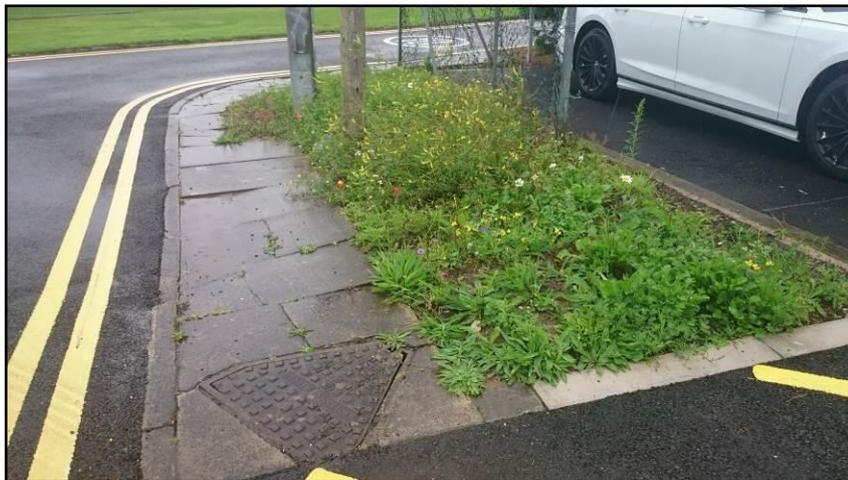
Photograph 9 showing the area of ephemeral/short perennial

- 3.7 A small area of ephemeral/short perennial is located on the peripheries of a car park (see Photograph 9). Species include Bird's-foot Trefoil *Lotus corniculatus*, Common Poppy *Papaver rhoeas*, Yarrow *Achillea millefolium*, Meadow Vetchling *Lathyrus pratensis*, Ribwort Plantain *Plantago lanceolata*, Creeping Thistle *Cirsium arvense*, Wavy Bitter-cress *Cardamine flexuosa* and Dandelion *Taraxacum officinale* agg.

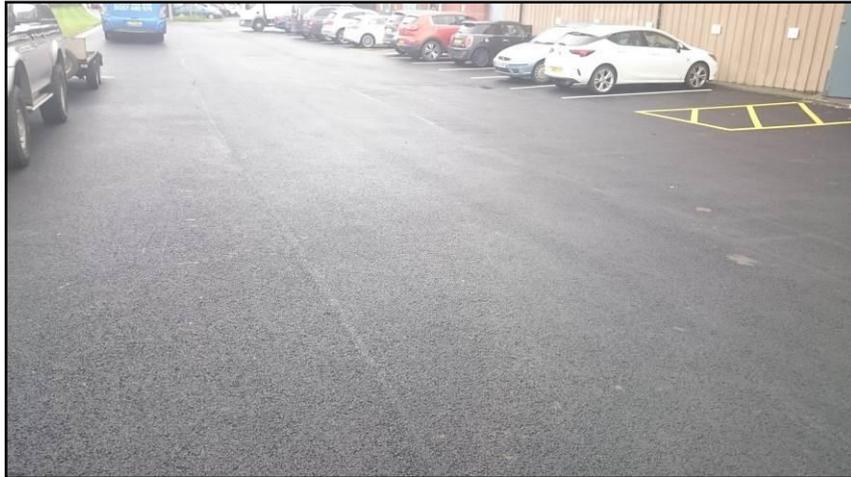
Photograph 10 showing one of the areas of bare ground

- 3.8 This habitat is located within the central area of the site and includes the access road, car park and turning spaces, tracks and paths (see Photographs 10 and 11).

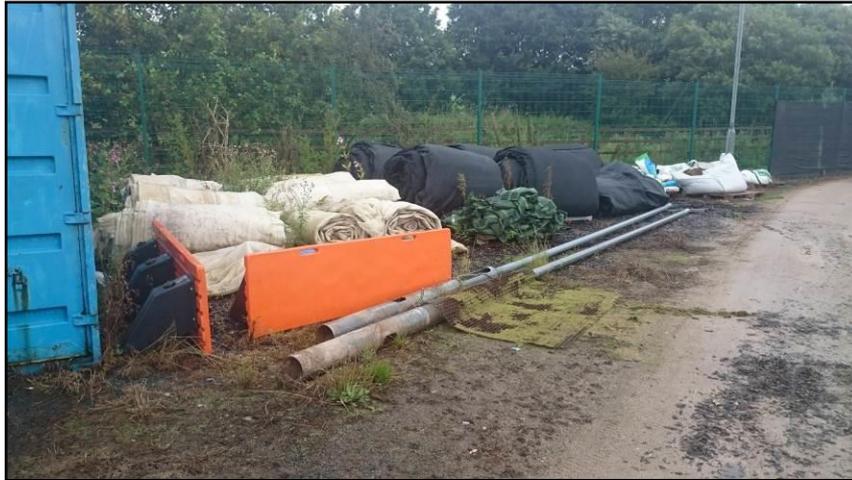
Photograph 12 showing one of the areas of spoil

- 3.10 A few piles of grounds maintenance equipment are present on site (see Photograph 12). These are referred to as spoil on the Phase 1 Habitat Map.

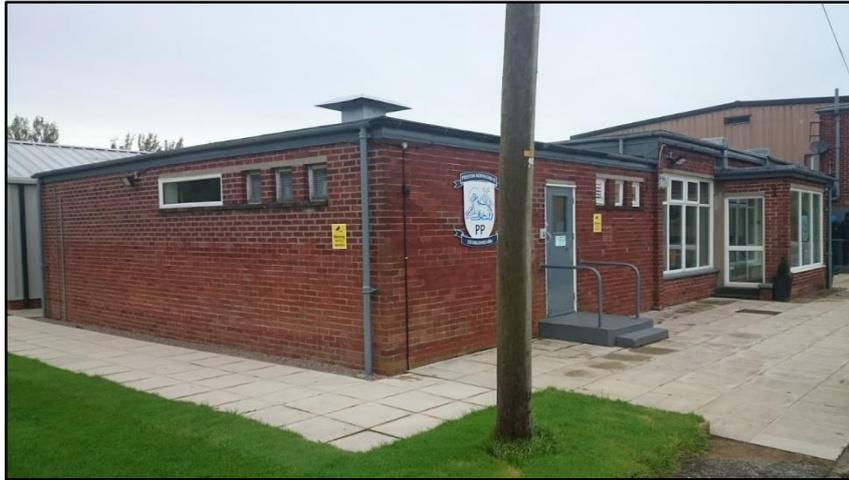
- 3.15 The building is single storey, brick-built with a flat roof (see Photograph 13). The building is currently in use as a changing facility and canteen. A double-height boiler room is also present on the north-eastern corner of the building (see Photograph 14).

Photograph 13 showing the building exterior

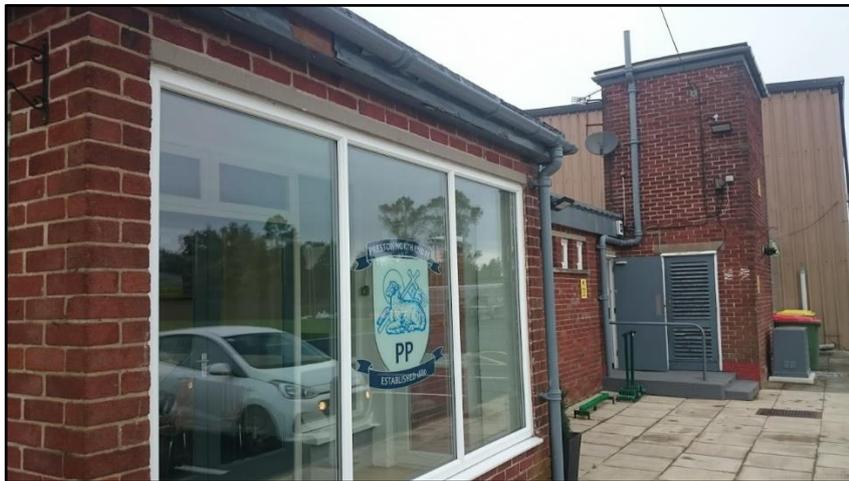
Photograph 14 showing the double-height boiler room

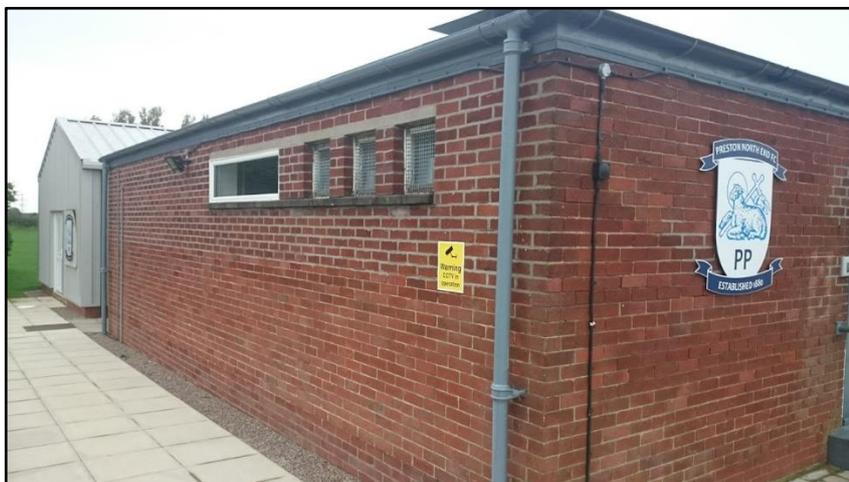
3.16 The external masonry is in good condition and well-sealed with mortar (see Photograph 15). The wood and uPVC window and door frames are in good condition and well-sealed to the surrounding masonry with no gaps or crevices present (see Photograph 16).

Photograph 15 showing the exterior of the building

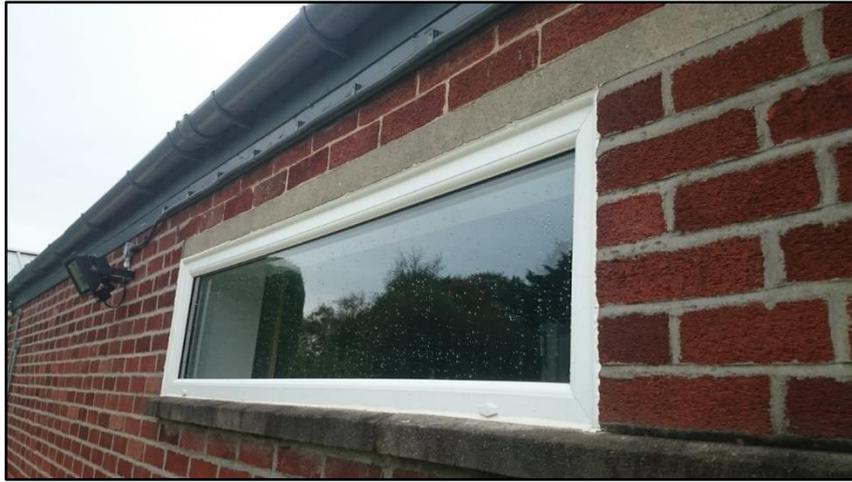
Photograph 16 showing one of the uPVC windows

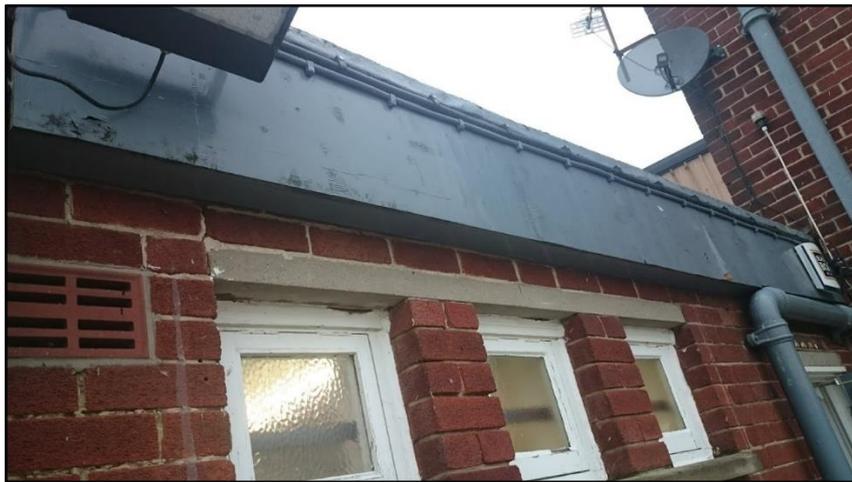
- 3.17 The roofs edges are lined with wood bargeboard and soffits. Despite some aesthetic degradation, the bargeboards and soffits are in reasonable condition, free from holes and cracks and are fitted flush to the surrounding masonry (see Photographs 17 and 18).

Photograph 17 showing a section of bargeboard and soffit

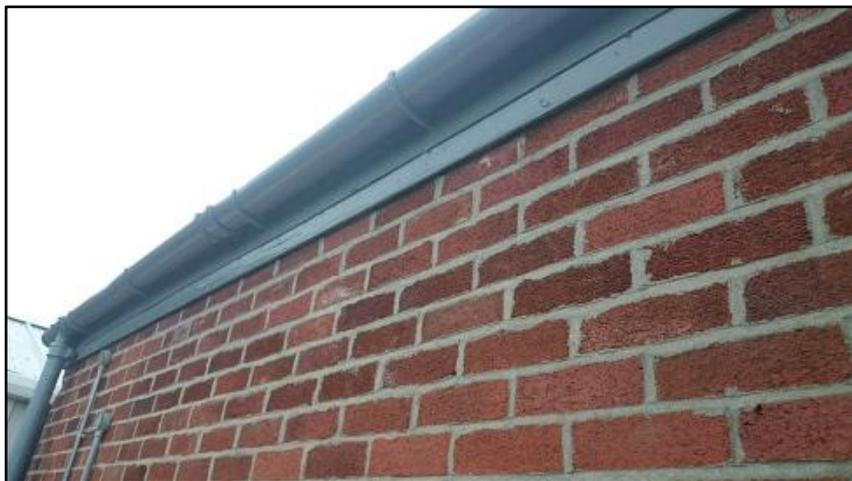
Photograph 18 showing a section of bargeboard

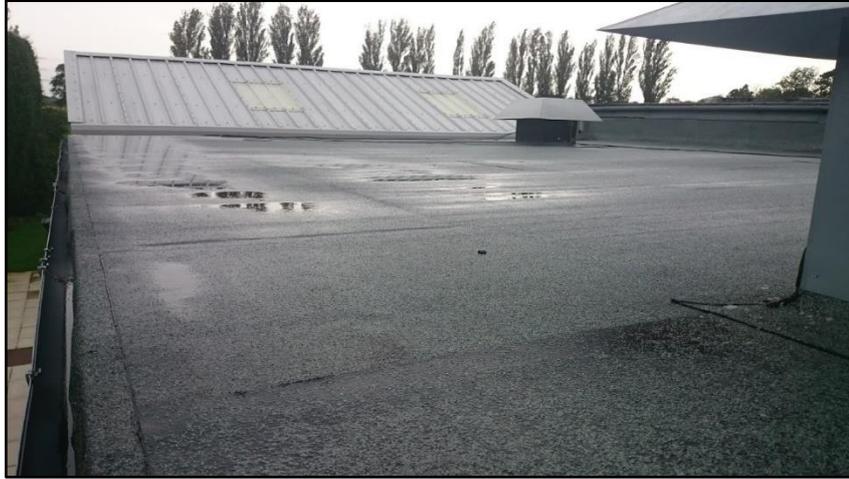
- 3.18 The roof of the building is flat and covered with roofing felt. The felt, though showing signs of past repairs, is complete, free from rips and tears bats may exploit (see Photographs 19 and 20).

Photograph 19 showing a section of the building's roof

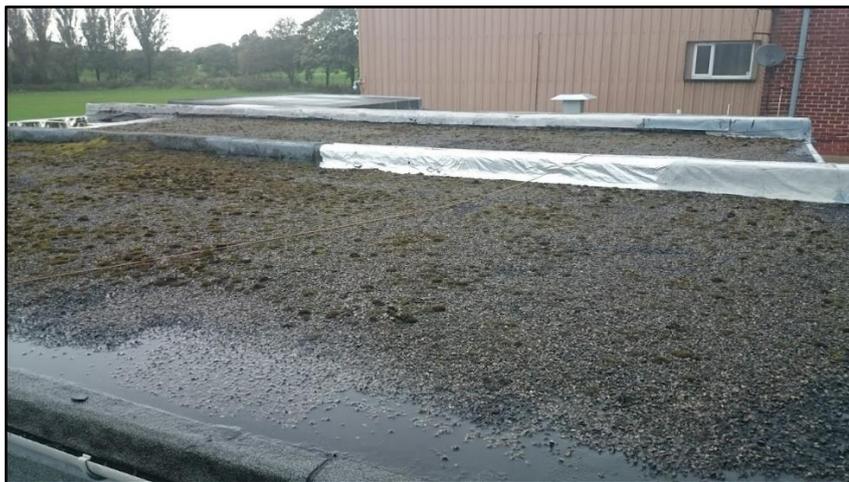
Photograph 20 showing a section of the building's roof

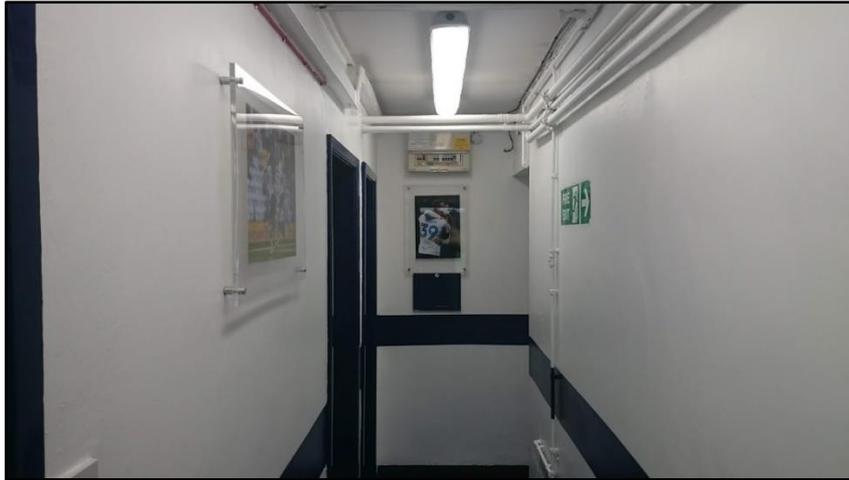
- 3.20 The internal spaces are well-finished rooms with no habitats associated with roosting bats present (see Photographs 21 and 22).

Photograph 21 showing one of the internal corridor spaces

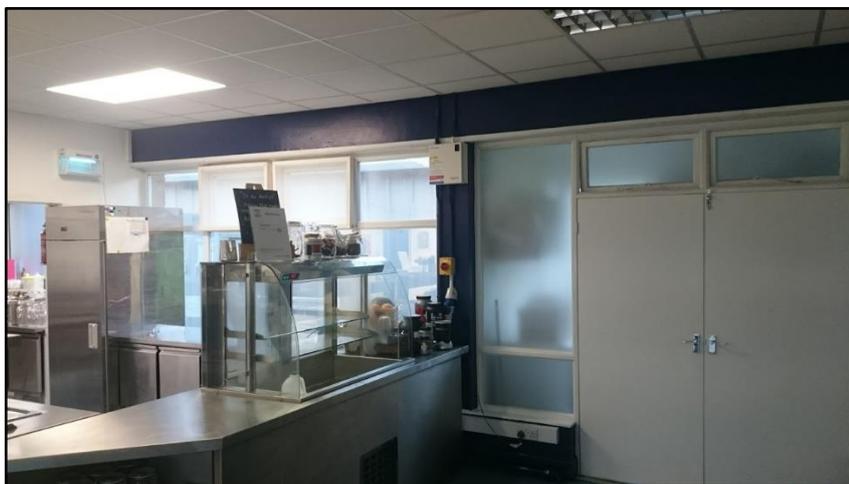
Photograph 22 showing a section of the canteen area

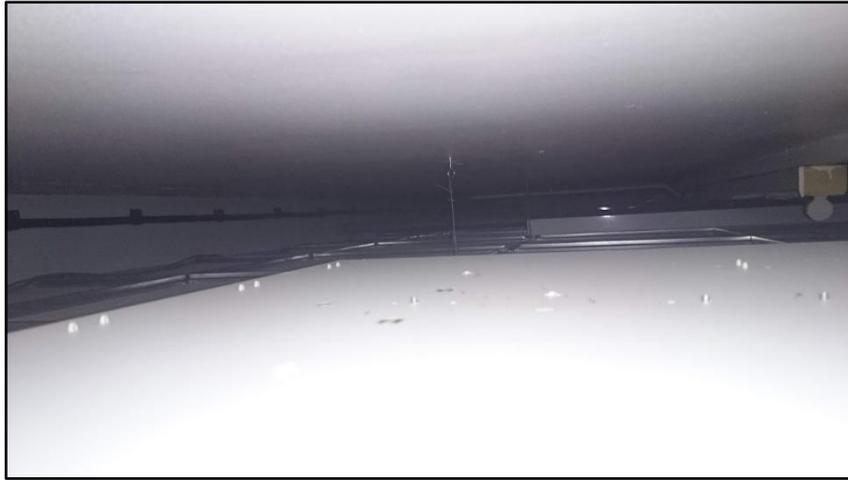
- 3.21 No roof void spaces are present at the internal rooms are built up to the underside of the flat roof. However, a false ceiling is located in the canteen area. A narrow void space is located between the underside of the flat roof and the tiles of the false ceiling. The narrow space consists of lighting and associated wiring (see Photograph 23). The space is narrow, dusty and cobwebbed. The space appears well-sealed, with no daylight seen.

Photograph 23 showing the narrow void space between the false ceiling and the underside of the flat roof

- 4.5 The identified building on site has been the subject of a daytime bat survey. No evidence of bat active was found internally or externally. The building is in good condition and well-sealed. A narrow void space is located in the canteen area between the false ceiling and the underside of the roof. This was found to be cobwebbed and dusty with no favourable roosting habitat present. No evidence of bat activity was found. Due to this and the lack of evidence found, the building, including the attached boiler room, is considered to offer **negligible bat roost suitability**. Therefore the building can be demolished with no further bat survey work needed.

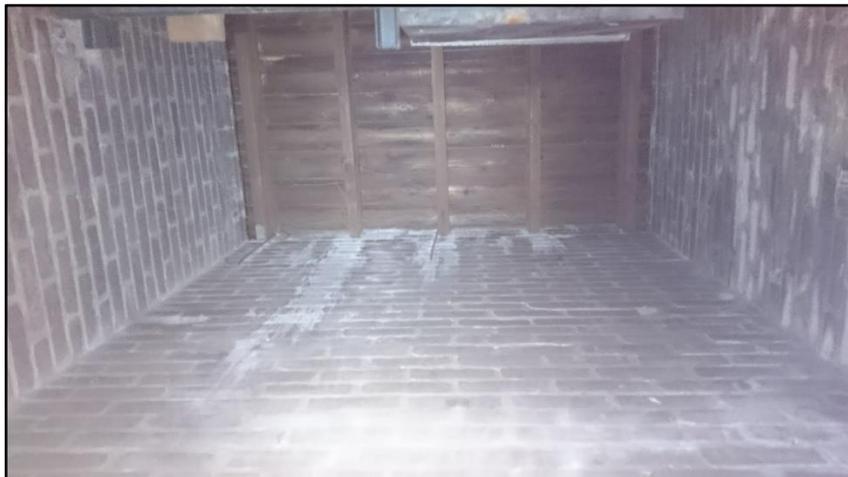
- 3.22 The internal space of the double-height boiler room is open to the underside of the roof with no roof void spaces present (see Photograph 24). The room is very duct and cobwebbed. The room is well-sealed with no daylight seen. No evidence of bat activity found in any of the internal spaces of the building.

Photograph 24 showing the internal space of the boiler room

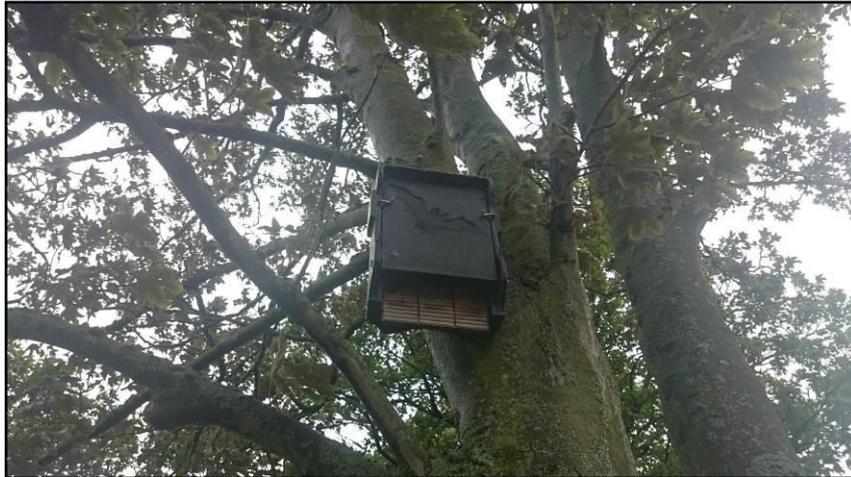
- 3.23 The proposals are not affecting any of the trees on site. Trees along the western boundary of the site were identified as having potential bat roost features (PRFs). Linear landscape features on the site, such as the hedgerows, continuous scrub and trees could be used for foraging and commuting by bats. Many of the trees across the site, particularly along the northern boundary, have bat boxes installed (see Photograph 25).

Photograph 25 showing one of the many bat boxes installed on an on-site tree

PRFs on the trees and/or bat boxes, prior to works commencing. Bats use linear landscape features for commuting and foraging. Bats may use the hedgerows, continuous scrub and trees on site for foraging and commuting and this is to be retained. The boundary habitats, especially the mature trees with PRFs and/or bat boxes, should be protected with a sensitive lighting scheme. No further bat survey work is considered necessary at this time and bats are not considered to be a constraint on development.

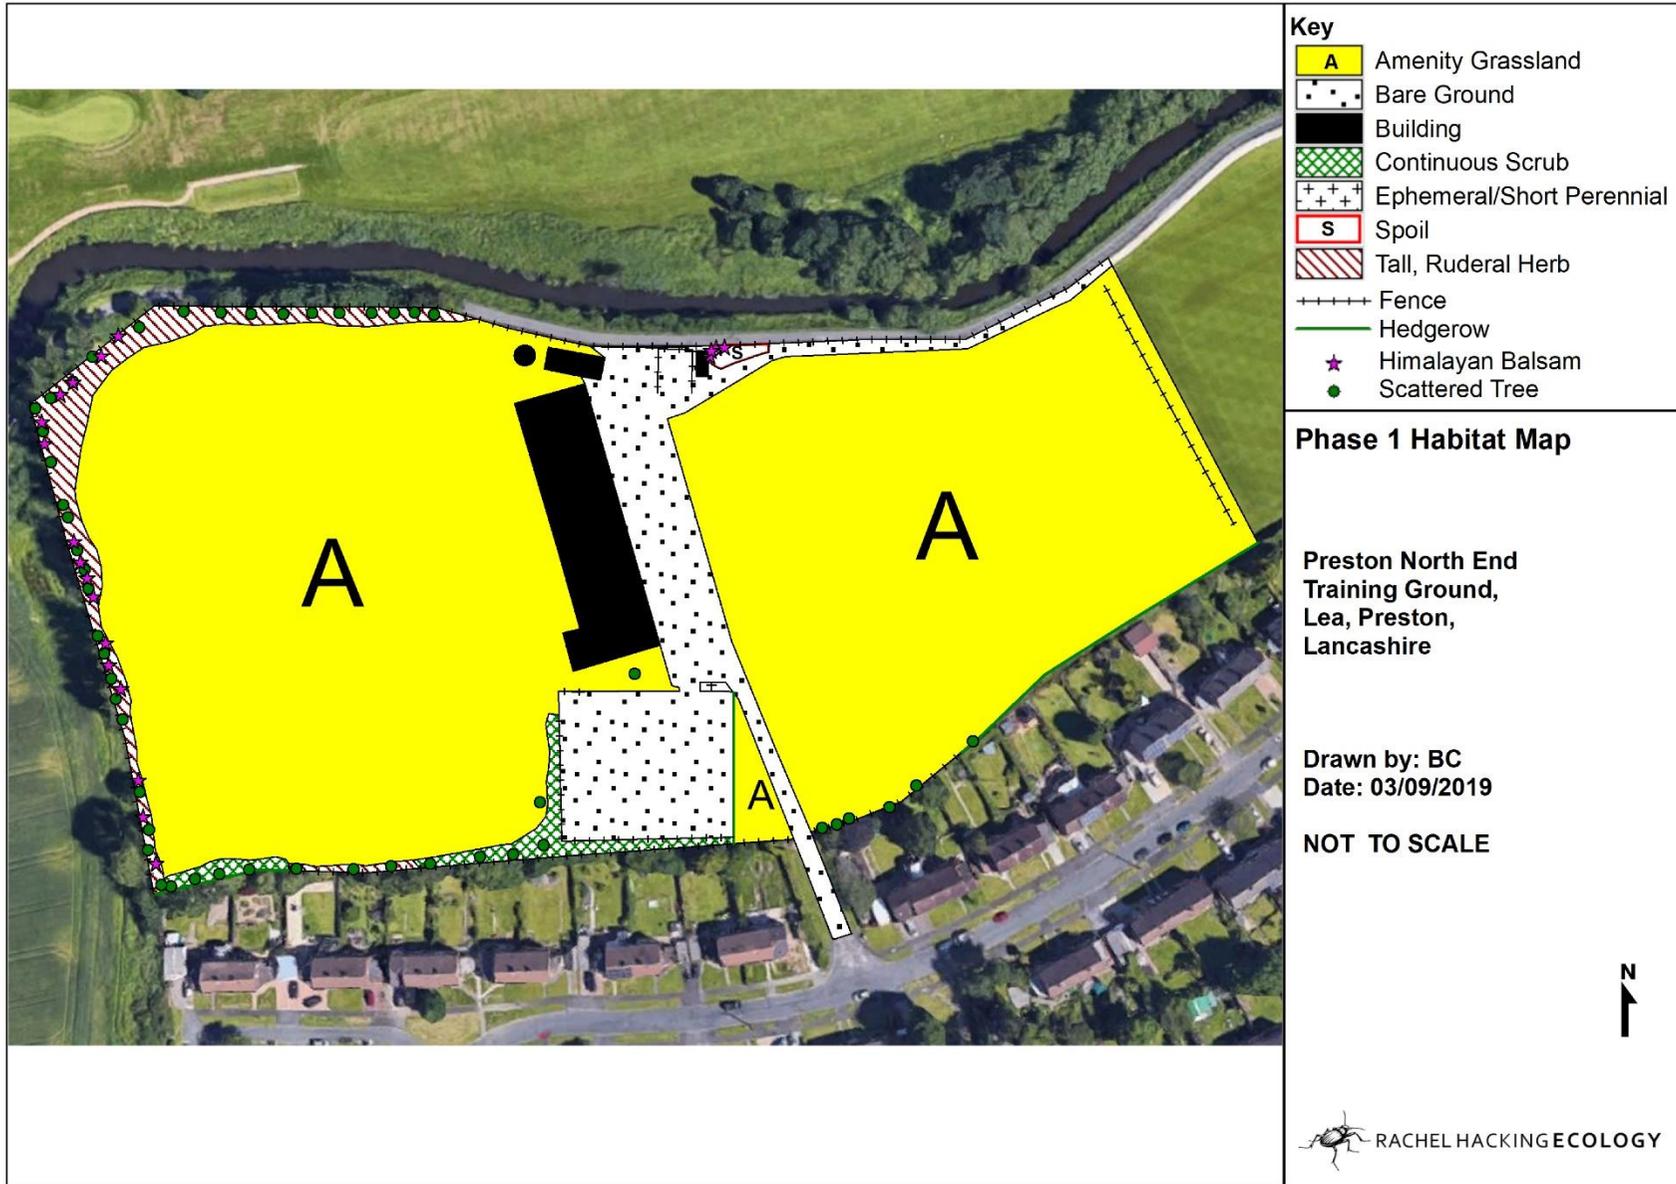
PHASE 1 HABITAT MAP

- 3.1 The Phase 1 Habitat Map can be found at the back of the report. The habitats present are described below.
